**Flood Control Project Maintenance
Levee Inspections**

Maintenance Issue Types Only, Levee Inspection Report By Mile - Spring 2017

Sutter Maintenance Yard East Levee Sacramento River

Waterway	Bank	Unit Miles	Inspection Start/End	Inspector
Unit No. 01 Sacramento River	Left	19.85	03/22/2017 03/22/2017	Bob Duffey

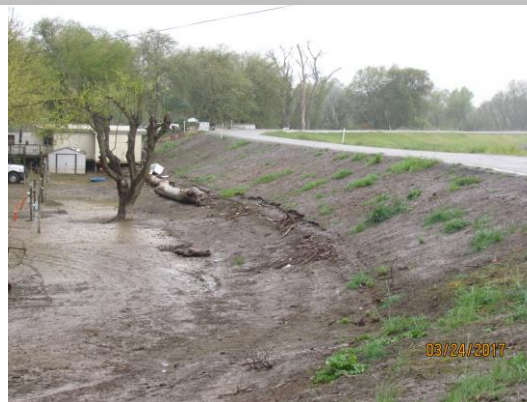
Photo 1 of 1 : SP_2017_ST0003_264_130_20170329_00180.jpg

LM Start	0.11	Rating **	M	Issue No.	130
LM End	0.14	Issue Type +	Ma	Location *	WS
Category	Earthen Levee			GPS Latitude/Longitude	
				Start	End
Item	Slope Stability			39.195163 °	39.195038 °
				-121.936815 °	-121.937435 °
DWR ID	DWR_ST0003_01_s_2017_130				
Comment Code					
S1 : Repair slope instability.					
Inspector Comment					
Repair the erosion along the waterside slope.

View of the erosion along the waterside slope.

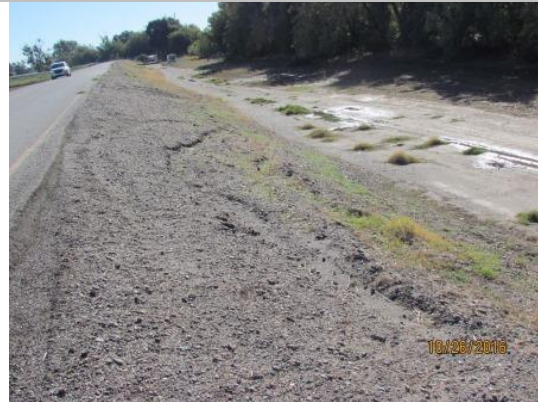
Photo 1 of 1 : SP_2017_ST0003_264_81_20170315_00025.jpg

LM Start	0.42	Rating **	M	Issue No.	81
LM End	0.42	Issue Type +	Ma	Location *	WS
Category	Earthen Levee			GPS Latitude/Longitude	
				Start	End
Item	Slope Stability			39.196483 °	39.196483 °
				-121.942228 °	-121.942228 °
DWR ID	DWR_ST0003_01_f_2016_81				
Comment Code					
S3 : Repair the levee slope damaged by vehicle traffic and prevent access where possible.					
Inspector Comment

View of the ruts along the waterside slope.

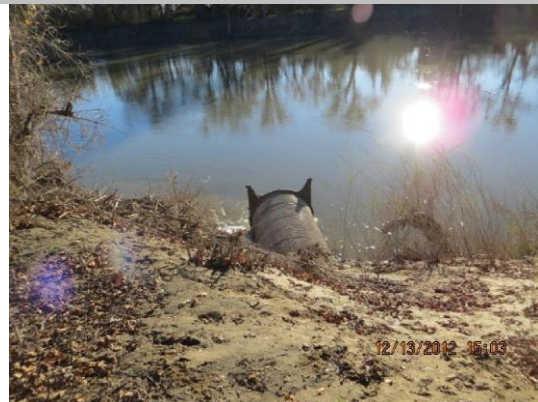
Photo 1 of 3 : UCIP_SP_2017_51650_46962.jpg

UCIP Comments: 4/24/2017 Both sides of crossing were underwater during site visit. Will need to revisit after water levels drop. (DWR Sutter Yard- A Freitag)11/7/2016 Crossing appears to be in good condition. (DWR Sutter Yard- A Freitag)6/6/2016 Crossing appears to be in good condition.4/6/2015 Good Condition. No issues. Semi circle CMP half riser in inlet structure on LS. Inlet opening has no trash rack, this may cause safety issue.6/30/2014 Same as last inspection.12/30/2013 Same as last inspection.7/29/2013 Same as last inspection.

Waterside view: overview towards CMP sewer pipe

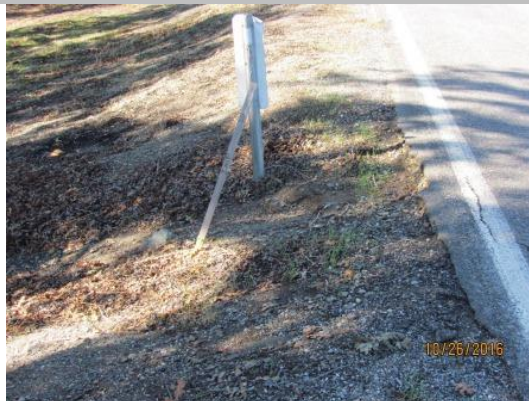
Photo 1 of 1 : SP_2017_ST0003_264_80_20170315_00024.jpg

LM Start	1.17	Rating **	M	Issue No.	80
LM End	1.17	Issue Type +	Ma	Location *	WS
Category	Earthen Levee			GPS Latitude/Longitude	
				Start	End
Item	Slope Stability			39.194126°	39.194126°
				-121.953345°	-121.953345°
DWR ID	DWR_ST0003_01_f_2016_80				
Comment Code					
S1 : Repair slope instability.					
Inspector Comment

View of the slope instability along the waterside slope.

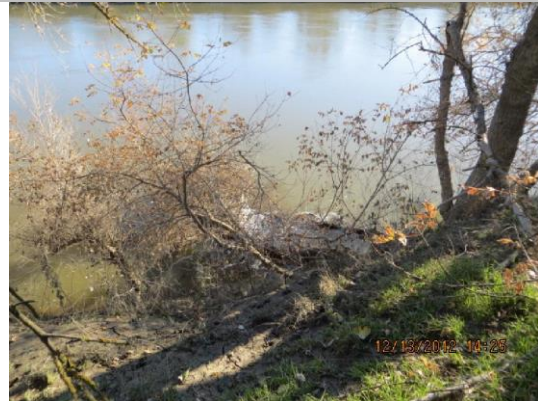
Photo 1 of 3 : UCIP_SP_2017_51655_46992.jpg

FS_ID:51655
DS_ID:17320
EP_NO: 9543
Repair Type: Urgent
Crossing Status: Found
UCIP Comments: 4/24/2017 WS was underwater during the site visit but I do not believe that any repairs have been made to this crossing yet. (DWR Sutter Yard- AFreitag)11/7/2016 No repairs have been made here yet. (DWR Sutter Yard- AFreitag)6/17/2016 River levels were down and the WS pipe end was exposed. WS end is completely rotten and damaged and flap gate has fallen off the end of the pipe (see pics). Pipe needs to be replaced or repaired. (DWR Sutter Yard - afreitag)4/5/2016 Erosion on WS slope still present. Pipe still fully submerged on WS and discharging into river during site visit. (DWR UCIP - kfazel)4/6/2015 Pipe leaks during high water. DWR employee said he suspects that the flap gate has rotted and fallen off WS end of pipe. Could not locate WS end of pipe to confirm. Water was flowing through this drain during field survey. (DWR Sutter Yard - afreitag)6/30/2014 Same as last inspection. (DWR Sutter Yard - afreitag)12/30/2013 Same as last inspection. (DWR Sutter Yard - afreitag)7/29/2013 Same as last inspection. (DWR Sutter Yard - afreitag) 12/13/2012 Water was flowing through this drain during field survey. (DWR UCIP - pamatya)

FIELD_STRUCT_DESC: 30-inch corrugated metal drainage pipe (at 45 degrees) through the levee, 25.2 feet below the crown. Flap gate on the waterside (WS), not found in 2016. (Automatic Board Order (ABO) issued as Permit No. 9543, 1974 - Harada). [Additional Reference(s): DWR Levee Log, 2002. USACE Sacramento O&M Manual 136, revision March 1960 (HLM 1.38)]
FS Date: 4/26/2017 9:57:29 AM

Waterside view: overview of river bank

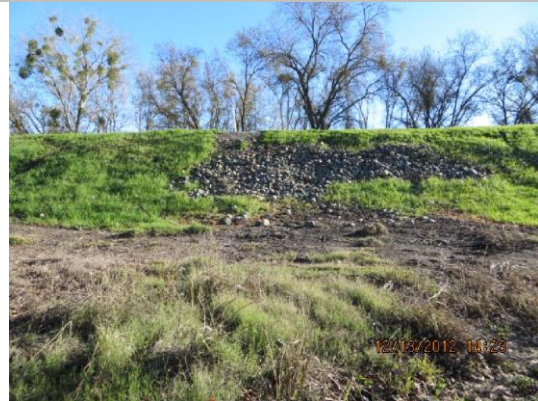
Photo 3 of 3 : UCIP_SP_2017_51655_46990.jpg

FS_ID:51655
DS_ID:17320
EP_NO: 9543
Repair Type: Urgent
Crossing Status: Found
UCIP Comments: 4/24/2017 WS was underwater during the site visit but I do not believe that any repairs have been made to this crossing yet. (DWR Sutter Yard- AFreitag)11/7/2016 No repairs have been made here yet. (DWR Sutter Yard- AFreitag)6/17/2016 River levels were down and the WS pipe end was exposed. WS end is completely rotten and damaged and flap gate has fallen off the end of the pipe (see pics). Pipe needs to be replaced or repaired. (DWR Sutter Yard - afreitag)4/5/2016 Erosion on WS slope still present. Pipe still fully submerged on WS and discharging into river during site visit. (DWR UCIP - kfazel)4/6/2015 Pipe leaks during high water. DWR employee said he suspects that the flap gate has rotted and fallen off WS end of pipe. Could not locate WS end of pipe to confirm. Water was flowing through this drain during field survey. (DWR Sutter Yard - afreitag)6/30/2014 Same as last inspection. (DWR Sutter Yard - afreitag)12/30/2013 Same as last inspection. (DWR Sutter Yard - afreitag)7/29/2013 Same as last inspection. (DWR Sutter Yard - afreitag) 12/13/2012 Water was flowing through this drain during field survey. (DWR UCIP - pamatya)

Landside view: overview of levee slope

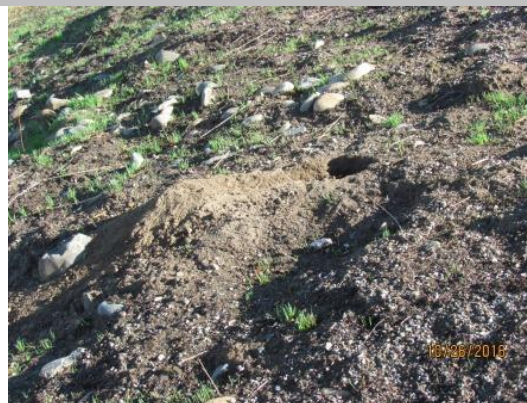
Photo 1 of 1 : SP_2017_ST0003_264_83_20170315_00026.jpg

View of the rodent holes along the landside slope.

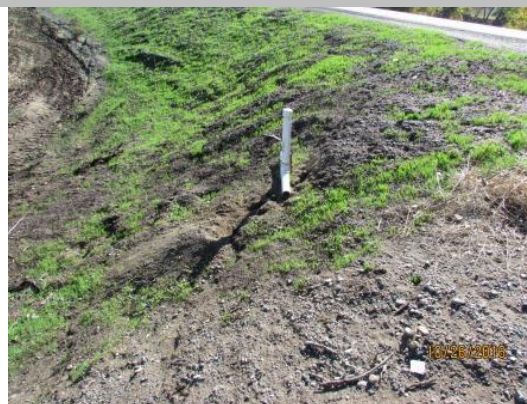
Photo 1 of 1 : SP_2017_ST0003_264_84_20170315_00027.jpg

LM Start	2.07	Rating **	M	Issue No.	84
LM End	2.07	Issue Type +	Ma	Location *	LS
Category	Earthen Levee			GPS Latitude/Longitude	
				Start	End
Item	Animal Control			39.187776 °	39.187776 °
				-121.967516 °	-121.967516 °
DWR ID	DWR_ST0003_01_f_2016_84				
Comment Code					
A1 : Exterminate rodents and backfill and compact or grout burrows.					
Inspector Comment

View of the rodent holes along the landside slope.

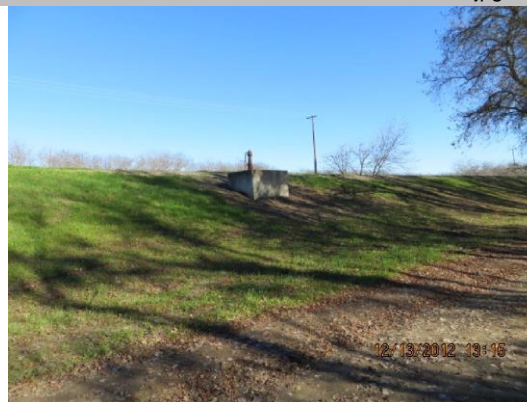
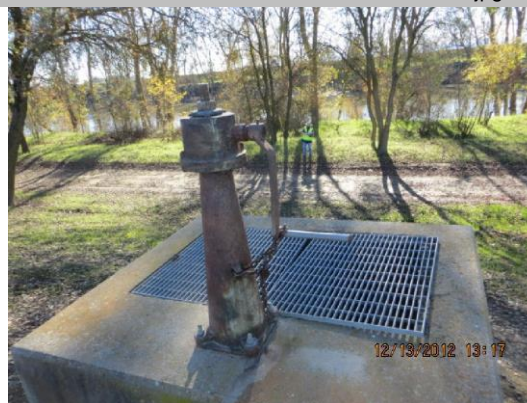
FS_ID:51660
DS_ID:17309
EP_NO: 9541
Repair Type: Non-Urgent
Crossing Status: Found
UCIP Comments: 4/24/2017 Still no sign of WS pipe end or flapgate.
LS appears to be in good condition. (DWR Sutter Yard- AFreitag)

11/7/2016 LS culvert measured to be 30" wide X 30" tall. WS end is not visible so could not be measured. (DWR Sutter Yard- AFreitag) 6/6/2016 Cannot locate the WS headwall/flapgate. Appears to have been silted over. 4/6/2015 Same as last inspection. Concrete surg box on WS. Flap gate in concrete "U" headwall at the waterward end- not found. 6/30/2014 Same as last inspection. 12/30/2013 Same as last inspection. 7/29/2013 Same as last inspection.
FIELD_STRUCT_DESC: 30-inch reinforced concrete box drainage culvert through the levee, 14.3 feet below the crown. 30-inch corrugated metal pipe connects concrete culvert from slide gate out to flap gate on the waterside (WS) end. Slide gate in a concrete riser on the waterside (WS) slope. (Automatic Board Order (ABO) issued as Permit No. 9541, 1974 - Wilbur, McGowan, Zinke). [Additional Reference(s): DWR Levee Logs, 2002. USACE Sacramento O&M Manual 136, March 1960 (HLM 2.49)].

Waterside view: overview- concrete surg tank

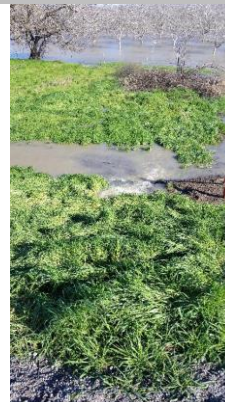
Photo 2 of 3 : UCIP_SP_2017_51665_76920.jpg

FS_ID:51665
DS_ID:17311
EP_NO: N/A
Repair Type: Urgent
Crossing Status: Found
UCIP Comments: 4/6/2017 Pipe was found in January 2017 during a high water event when water uncovered the buried WS end which led to uncontrolled water flow through during the high water event. The WS pipe opening was temporarily blocked off by plywood and sandbags until the pipe can be properly plugged or abandoned. Pics updated.
(DWR Sutter Yard- Afreitag)11/7/2016 Unable to locate. (DWR Sutter Yard- AFreitag)6/6/2016 Unable to locate.4/6/2015 Unable to locate.6/30/2014 Unable to locate.12/30/2013 Unable to locate.7/29/2013 Same as last inspection. Unable to locate.
FIELD_STRUCT_DESC: *ABANDONED* 24-inch corrugated metal drainage pipe through the levee, 12.4 feet below the crown. Slide gate on the waterside (WS) end. Pipe silted over on both ends. (Automatic Board Order (ABO) issued as Permit No. 9539, 1974 - Locvich).

LS view from levee shoulder

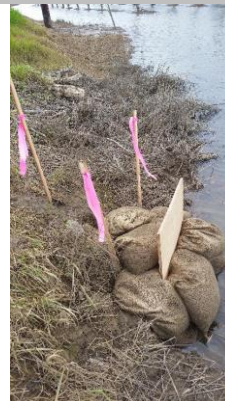
Photo 3 of 3 : UCIP_SP_2017_51665_76921.jpg

WS view of the temporary plug on WS end.

Comment Code					
Inspector Comment					
FS_ID:51665 DS_ID:17311 EP_NO: N/A Repair Type: Urgent Crossing Status: Found UCIP Comments: 4/6/2017 Pipe was found in January 2017 during a high water event when water uncovered the buried WS end which led to uncontrolled water flow through during the high water event. The WS pipe opening was temporarily blocked off by plywood and sandbags until the pipe can be properly plugged or abandoned. Pics updated. (DWR Sutter Yard- Afreitag)11/7/2016 Unable to locate. (DWR Sutter Yard- Afreitag)6/6/2016 Unable to locate.4/6/2015 Unable to locate.6/30/2014 Unable to locate.12/30/2013 Unable to locate.7/29/2013 Same as last inspection. Unable to locate. FIELD_STRUCT_DESC: *ABANDONED* 24-inch corrugated metal drainage pipe through the levee, 12.4 feet below the crown. Slide gate on the waterside (WS) end. Pipe silted over on both ends. (Automatic Board Order (ABO) issued as Permit No. 9539, 1974 - Locvich). [Additional Reference(s): DWR Levee Log, 2002. USACE Sacramento O&M Manual 136, March 1960 (HLM 3.25)]. FS Date: 4/26/2017 12:09:42 PM

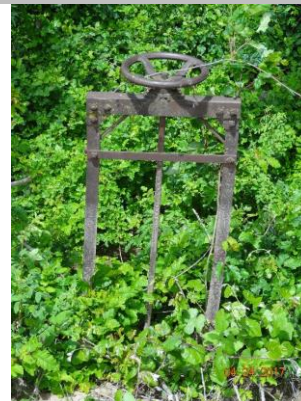
Photo 1 of 2 : UCIP_SP_2017_51666_77004.jpg

FS_ID:51666
DS_ID:17313
EP_NO: N/A
Repair Type: Non-Urgent
Crossing Status: Found
UCIP Comments: 4/24/2017 Slide gate structure found on WS about 10ft from levee toe. Vegetation was too thick to see if there were any appurtances associated with this crossing visible on the WS. Nothing was visible on the LS. House located above pipe alignment at LS levee toe. Crossing appears abandoned and should be done so properly. (DWR Sutter Yard- AFreitag)11/7/2016 Unable to locate. (DWR Sutter Yard- AFreitag)6/6/2016 Unable to locate.4/6/2015 Unable to locate.6/30/2014 Unable to locate.12/30/2013 Unable to locate7/29/2013 Same as last inspection. Unable to locate.
FIELD_STRUCT_DESC: *ABANDONED* 18-inch corrugated metal drainage pipe through the levee, 15 feet below the crown. Slide gate on the waterside (WS) end. [Additional Reference(s): DWR Levee Log, 2002. USACE Sacramento O&M Manual 136, March 1960 (HLM 3.6)].

Slide gate structure found on WS

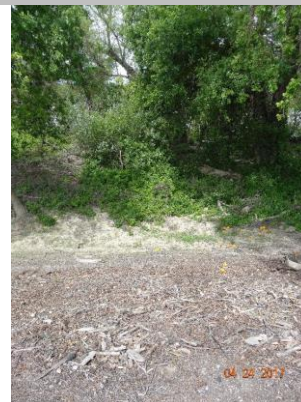
Photo 2 of 2 : UCIP_SP_2017_51666_77005.jpg

View of WS from levee shoulder

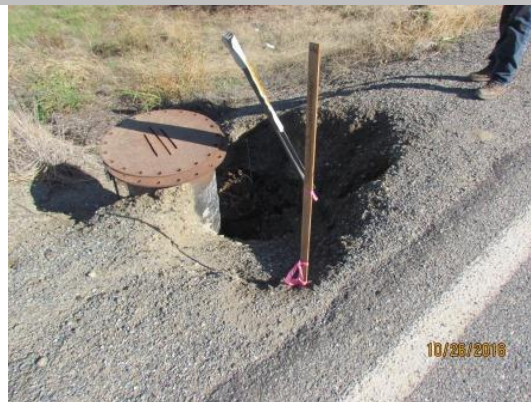
Photo 1 of 1 : SP_2017_ST0003_264_106_20170315_00033.jpg

LM Start	4.64	Rating **	M	Issue No.	106
LM End	4.64	Issue Type +	Ma	Location *	LS
Category	Earthen Levee			GPS Latitude/Longitude	
				Start	End
Item	Erosion / Bank Caving			39.212632 °	39.212632 °
				-121.990409 °	-121.990409 °
DWR ID	DWR_ST0003_01_f_2016_106				
Comment Code					
E2 : Schedule repair of erosion site prior to the next inspection.					
Inspector Comment

View of the erosion next to a pipe along the landside slope.

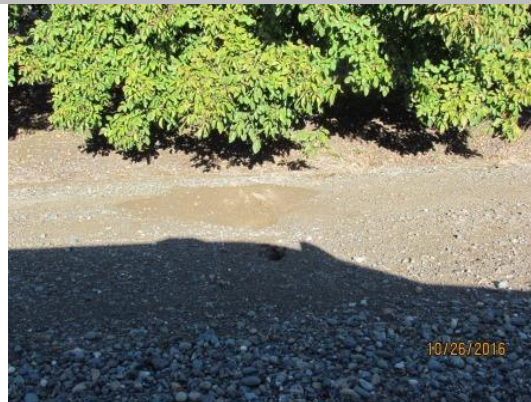
Photo 1 of 1 : SP_2017_ST0003_264_101_20170315_00031.jpg

View of the rodent holes along the landside slope.

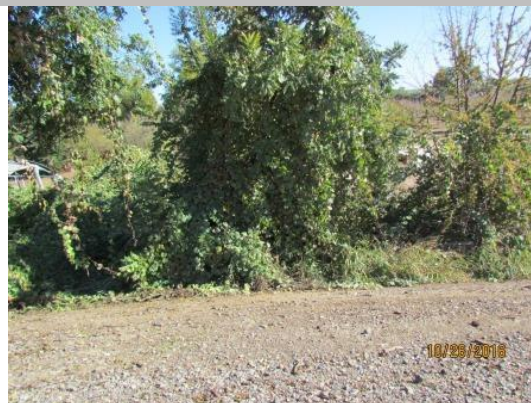
Photo 1 of 1 : SP_2017_ST0003_264_99_20170315_00029.jpg

View of the overgrown vegetation along the landside slope.

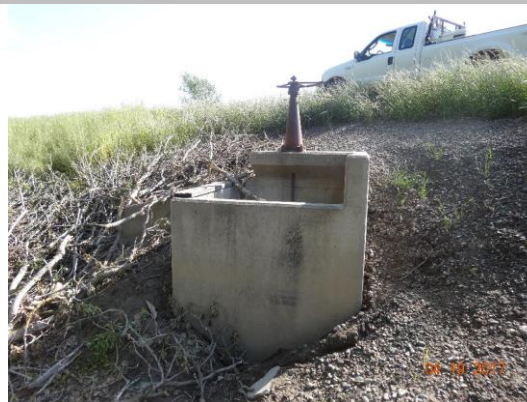
Photo 2 of 3 : UCIP_SP_2017_51695_77009.jpg

FS_ID:51695
DS_ID:17301
EP_NO: 9532
Repair Type: Non-Urgent
Crossing Status: Found
UCIP Comments: 4/19/2017 Abandoned- erosion/depression present around the WS box (DWR Sutter Yard- AFreitag)10/31/2016 Abandoned and erosion still present near WS box.(DWR Sutter Yard- AFreitag)6/1/2016 Appears to be an abandoned crossing.4/1/2015 Silted concrete box on WS. Depression/erosion around concrete box on WS.Silted concrete box on WS. Depression/erosion around concrete box on WS.6/30/2014 Same as last inspection.12/18/2013 Same as last inspection.7/23/2013 Same as last inspection.
FIELD_STRUCT_DESC: *ABANDONED* 36-inch by 48-inch reinforced concrete box drainage culvert through the levee, 11.6 feet below the crown. Slide gate in a concrete box on the waterside (WS) slope. (Automatic Board Order (ABO) issued as Permit No. 9532, 1974 - Martin). [Additional Reference(s): DWR Levee Log, 2002. USACE Sacramento O&M Manual 136, March 1960 (HLM 7.73)].

depression around WS concrete box

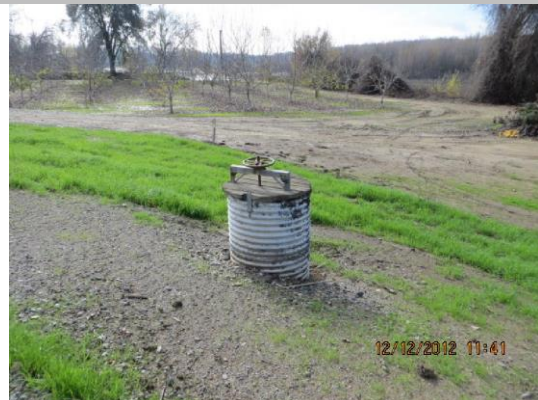
Photo 2 of 3 : UCIP_SP_2017_51698_47201.jpg

FS_ID:51698
DS_ID:17304
EP_NO: 9529
Repair Type: Non-Urgent
Crossing Status: Found
UCIP Comments: 4/19/2017 Abandoned- needs to be done properly. (DWR Sutter Yard- AFreitag)10/31/2016 Abandoned (DWR Sutter Yard- AFreitag)6/1/2016 Abandoned- only WS riser and slide gate found.4/1/2015 CMP riser and slide gate on WS. LS distribution box is silted in. Looks abandoned. CMP riser with slide gate on WS. Concrete distribution box on LS- full with silt.6/30/2014 Same as last inspection.12/18/2013 Same as last inspection.7/23/2013 Same as last inspection.
FIELD_STRUCT_DESC: *ABANDONED* 24-inch corrugated metal drainage pipe through the levee, invert 12.8 feet below the crown. Slide gate in a corrugated metal pipe (CMP) riser on the waterside (WS) slope. Concrete box at the landside (LS) toe. (Automatic Board Order (ABO) issued as Permit No. 9529, 1974 - Dorwood Ranching Company). [Additional Reference(s): DWR Levee Log, 2002. USACE Sacramento O&M Manual 136, March 1960 (HLM 8.35)].

Waterside view: overview of CMP riser

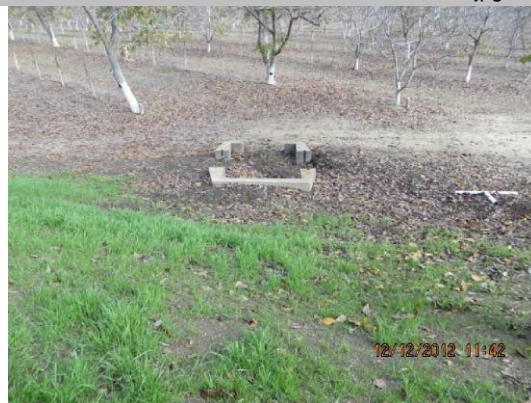
Photo 3 of 3 : UCIP_SP_2017_51698_47200.jpg

FS_ID:51698
DS_ID:17304
EP_NO: 9529
Repair Type: Non-Urgent
Crossing Status: Found
UCIP Comments: 4/19/2017 Abandoned- needs to be done properly. (DWR Sutter Yard- AFreitag)10/31/2016 Abandoned (DWR Sutter Yard- AFreitag)6/1/2016 Abandoned- only WS riser and slide gate found.4/1/2015 CMP riser and slide gate on WS. LS distribution box is silted in. Looks abandoned. CMP riser with slide gate on WS. Concrete distribution box on LS- full with silt.6/30/2014 Same as last inspection.12/18/2013 Same as last inspection.7/23/2013 Same as last inspection.
FIELD_STRUCT_DESC: *ABANDONED* 24-inch corrugated metal drainage pipe through the levee, invert 12.8 feet below the crown. Slide gate in a corrugated metal pipe (CMP) riser on the waterside (WS) slope. Concrete box at the landside (LS) toe. (Automatic Board Order (ABO) issued as Permit No. 9529, 1974 - Dorwood Ranching Company). [Additional Reference(s): DWR Levee Log, 2002. USACE Sacramento O&M Manual 136, March 1960 (HLM 8.35)].

Landside view: overview of concrete box

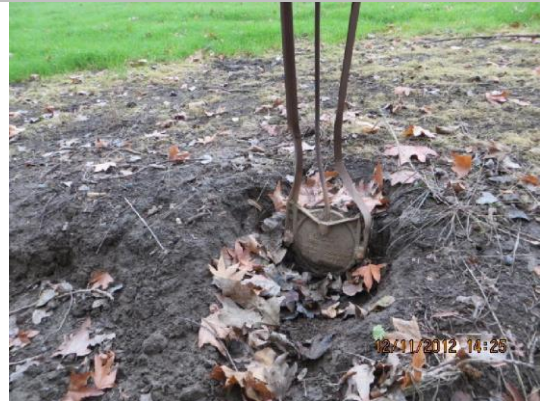
Photo 2 of 3 : UCIP_SP_2017_51729_47215.jpg

Waterside view: slide gate on steel structure (belongs to crossing at CLM-8.782)

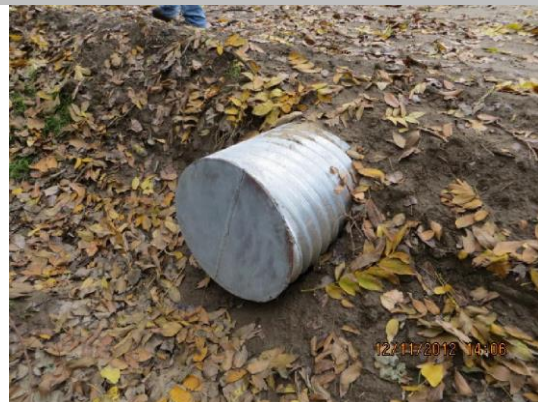
Photo 3 of 3 : UCIP_SP_2017_51731_47240.jpg

Waterside view: capped CMP pipe

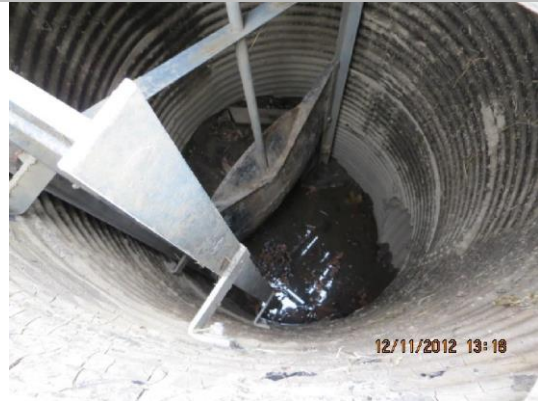
Photo 3 of 3 : UCIP_SP_2017_51734_47268.jpg

Waterside view: inside CMP riser

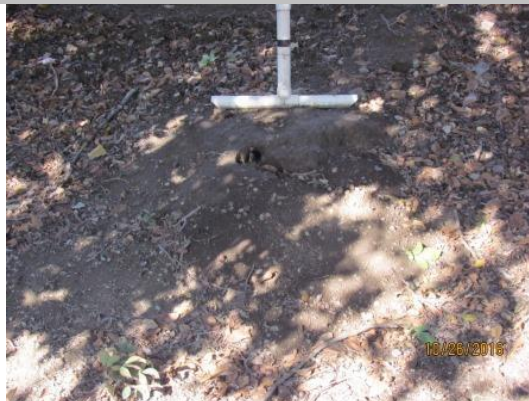
Photo 1 of 1 : SP_2017_ST0003_264_77_20170315_00023.jpg

View of the rodent holes along the landside slope.

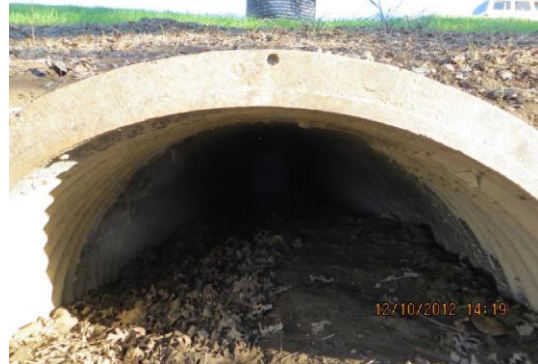
Photo 3 of 3 : UCIP_SP_2017_51749_47341.jpg

Waterside view: silted concrete lined CMP outlet pipe

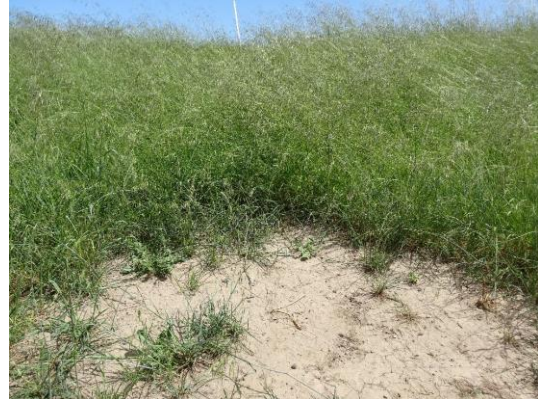
Photo 3 of 3 : UCIP_SP_2017_51759_75098.jpg

Looking up WS slope: bare spot where pipe was previously excavated, video inspected, and backfilled.

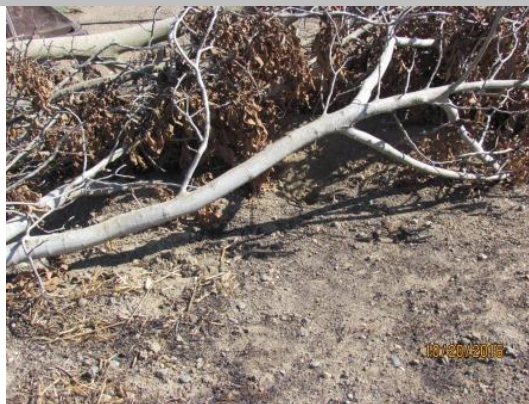
Photo 1 of 1 : SP_2017_ST0003_264_67_20170315_00016.jpg

View of the rodent holes along the landside slope under the tree limb.

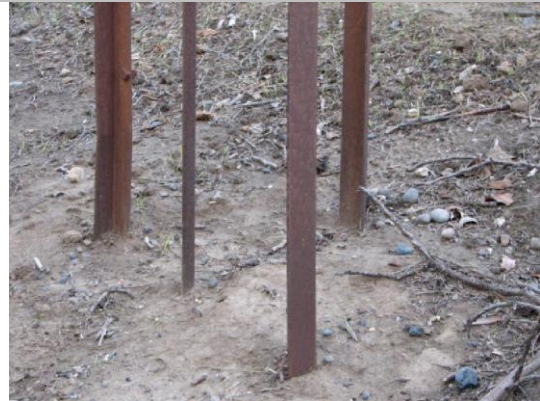
Photo 3 of 3 : UCIP_SP_2017_51762_47385.jpg

Waterside view: buried slide gate

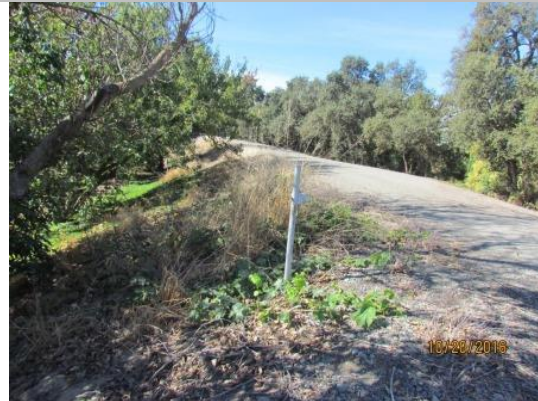
Photo 1 of 1 : SP_2017_ST0003_264_60_20170315_00011.jpg

View of the grape vine and annual grass along the landside slope.

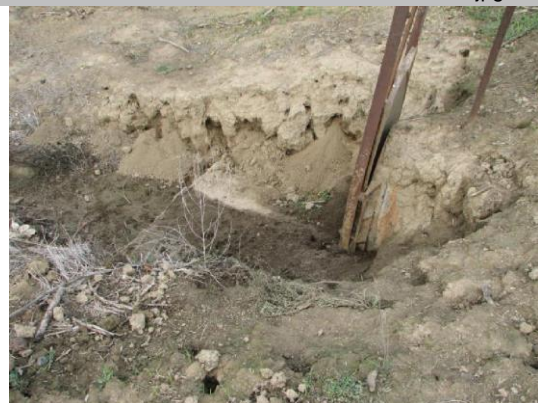
Photo 3 of 3 : UCIP_SP_2017_51770_47403.jpg

Waterside view: sloughing at outlet pipe

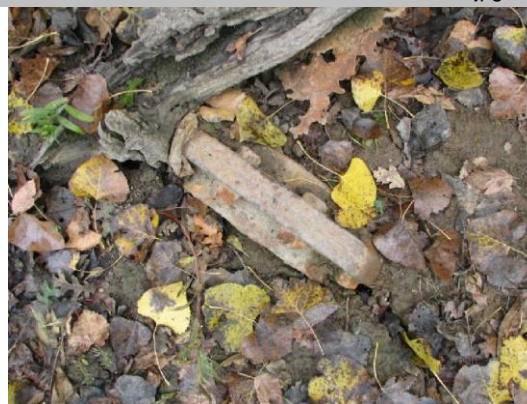
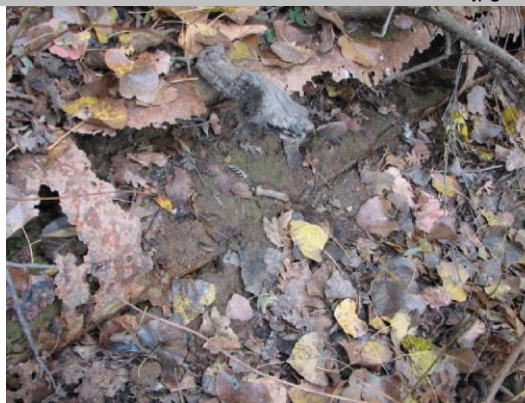
Waterside view: abandoned and ruined pipe

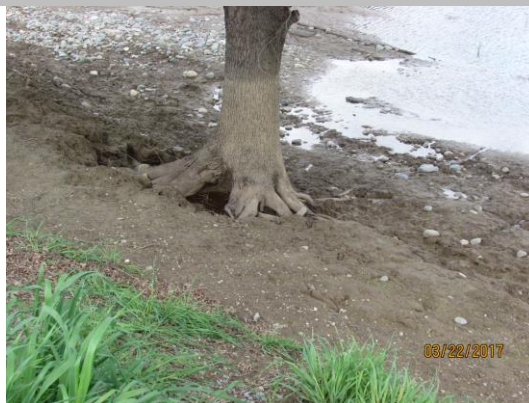
Photo 1 of 1 : SP_2017_ST0003_265_6_20170329_00007.jpg

View of the erosion along the oak tree.

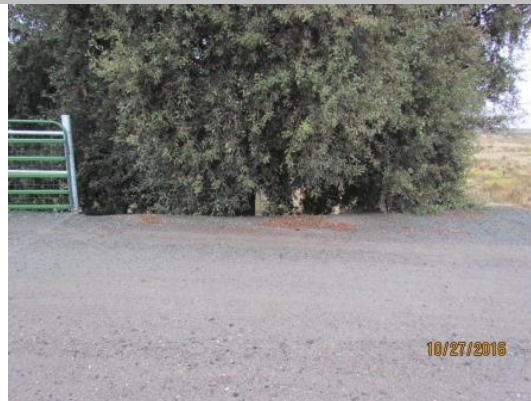
Photo 1 of 1 : SP_2017_ST0003_265_3_20170315_00001.jpg

View of the overgrown tree along the waterside slope.

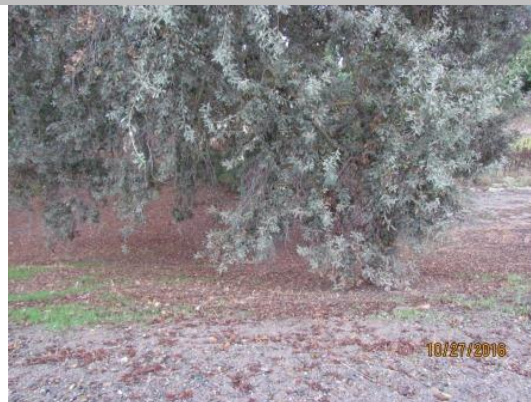
Photo 1 of 1 : SP_2017_ST0003_265_5_20170315_00003.jpg

View of the overgrown tree along the landside toe.

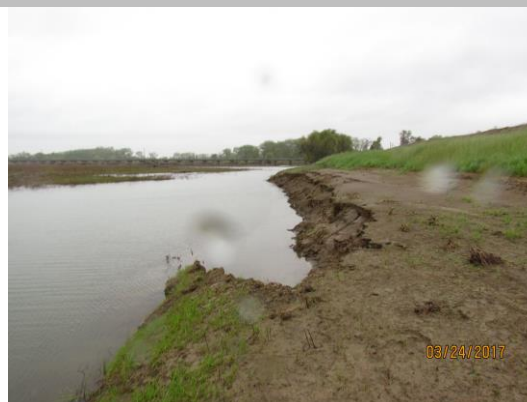
Photo 1 of 1 : SP_2017_ST0003_266_9_20170329_00008.jpg

View of the erosion along the waterside slope and toe.

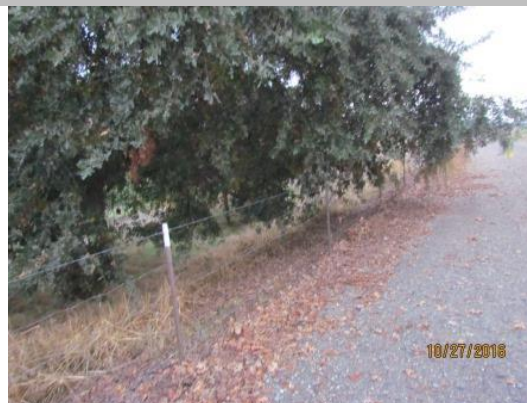
Photo 1 of 1 : SP_2017_ST0003_266_3_20170315_00002.jpg

View of a tree along the landside slope.

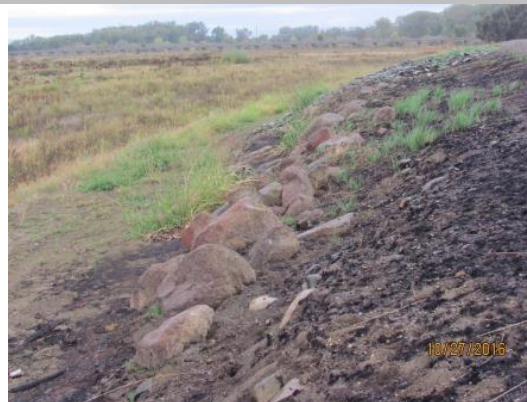
Photo 1 of 1 : SP_2017_ST0003_266_7_20170315_00006.jpg

View of the erosion along the waterside slope.

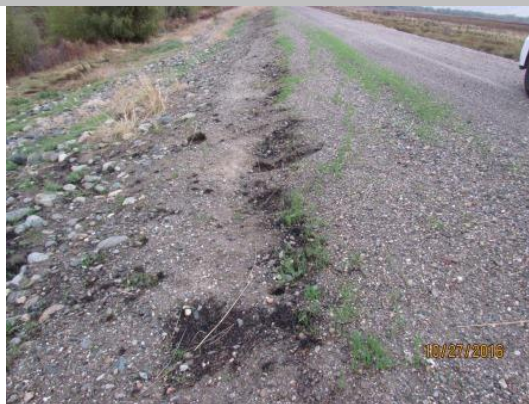
Photo 1 of 1 : SP_2017_ST0003_266_4_20170315_00003.jpg

View of the slope instability along the landside slope.
